The Church of Saint George

in the settlement of Saint George Sykoysis on Chios Island

The Restoration Project
and the Conservation of the Wall Paintings

MINISTRY OF CULTURE AND SPORTS
EPHORATE OF ANTIQUITIES OF CHIOS

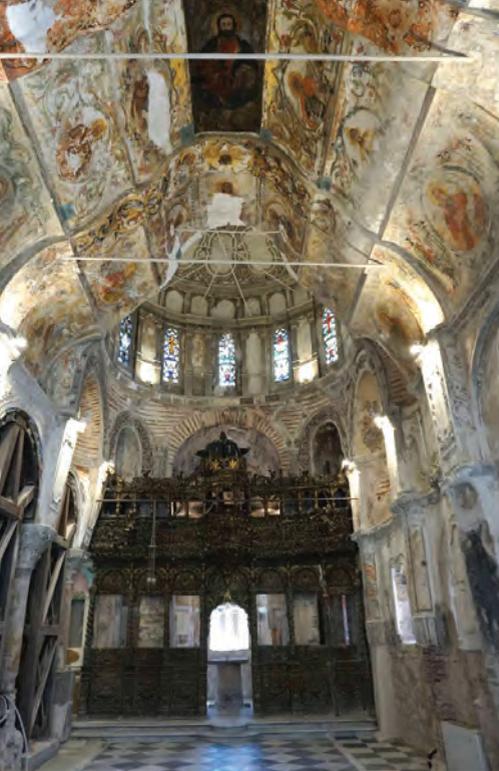
The Byzantine part of the church after the restoration project

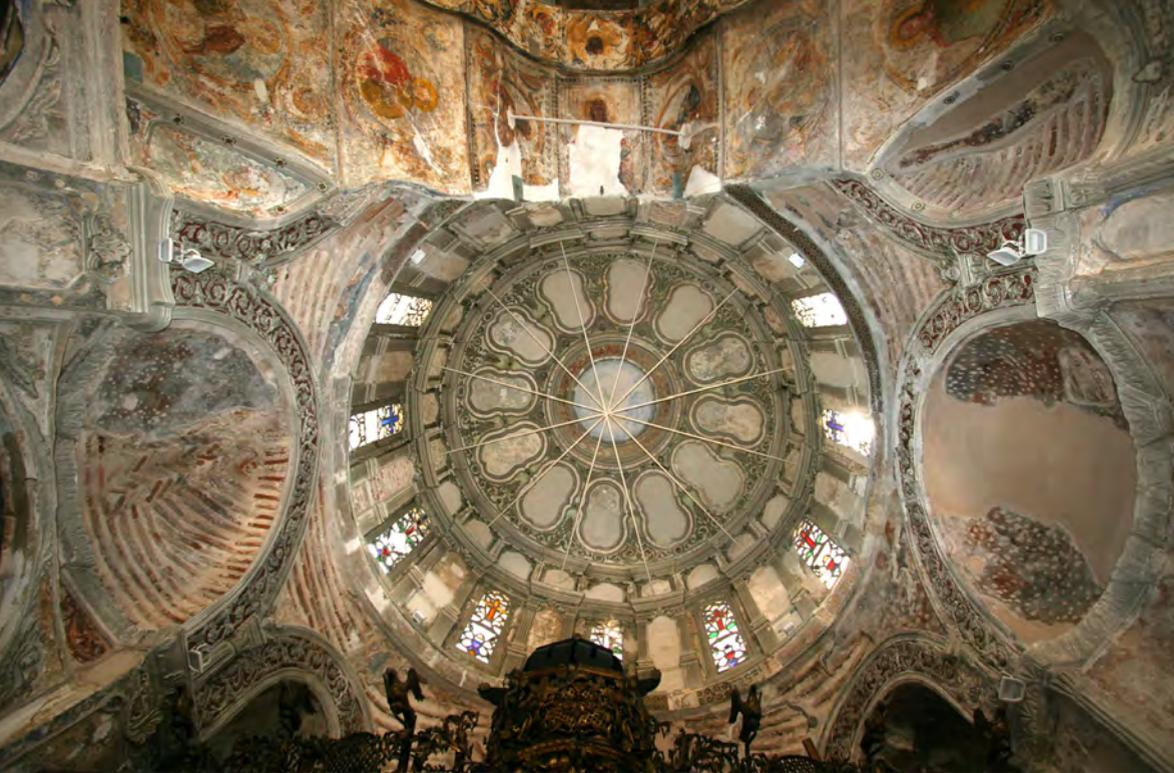
The Byzantine part of the church after the restoration project

The removal of all modern concrete renders from the church’s façades in 2017 revealed all those elements that link this monument to the so-called architectural “school of Constantinople”, such as the recessed brick masonry technique, blind arches, shallow conches, brick arches, and the extensive use of decorative brickwork, and ceramic quatrefoils. The various repairs and modifications that the monument underwent throughout

its long history are now evident on the exposed façades; these include the alteration of the original arched end of the south façade, as well as a number of subsequently sealed openings. Traces of a rose-hued mortar render were also discovered in the construction joints between the original Byzantine masonry and that of the more recent additions, evidence that may indicate that the initial church was covered in render either right from the start, or at some subsequent building phase.

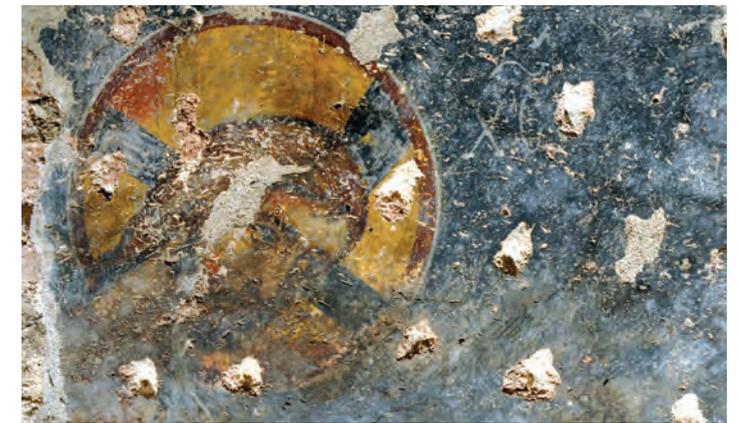
Agony in the Garden of Gethsemane, detail

scene in the bema conch, fragments of a narrative scene on the north wall of the bema, fragments of hierarch frontal portraits on the walls of the bema and the diakonikon, two scenes from the Agony in the Garden of Gethsemane in the diakonikon conch, monks and saints in the prothesis conch, a fragment of a youthful figure (angel?) below the central dome, and decorative motifs on the south wall of the main church.

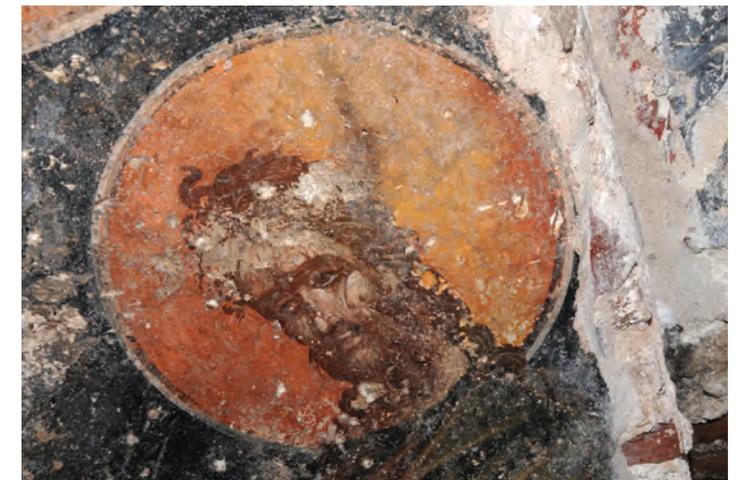
Deësis, detail of Saint John the Precursor

A Deësis scene on the bema conch, and a fragment from an Ascension scene on the north art of the bema apse, might also be associated with the renovation of the monastery by the monk Sophronios Sepsis in the early 16th century.
